**Flood Control Project Maintenance
Levee Inspections**
LMA District Cover Sheet
Spring 2017 Levee Inspection Results

Reclamation District No. 0544 Upper Roberts Island

Spring 2017 Levee Inspection Results

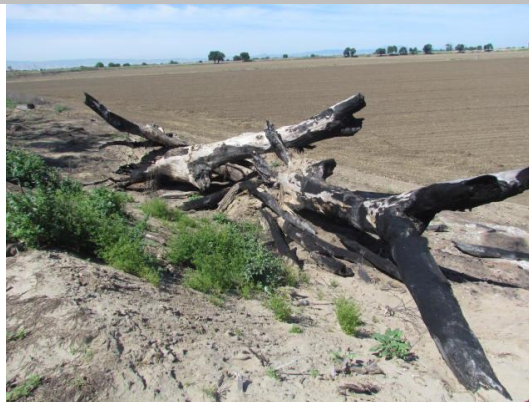
Photo 1 of 2 : SP_2017_RD0544_108_124_20170316_00087.jpg

LM Start	5.82	Rating **	U	Issue No.	124
LM End	5.82	Issue Type +	Ma	Location *	LS
Category	Earthen Levee			GPS Latitude/Longitude	
				Start	End
Item	Encroachments			37.811049 °	37.811049 °
				-121.325451 °	-121.325451 °
DWR ID	DWR_RD0544_01_s_2016_124				
Comment Code					
TR : Tree or limb					
Inspector Comment

Looking east at tree limbs on waterward slope.

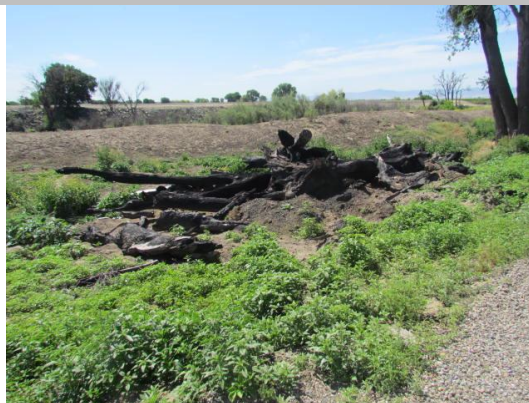
Photo 2 of 2 : SP_2017_RD0544_108_124_20170316_00088.jpg

LM Start	5.82	Rating **	U	Issue No.	124 (cont)	
LM End	5.82	Issue Type +	Ma	Location *	LS	
Category	Earthen Levee			GPS Latitude/Longitude		
				Start	End	
Item	Encroachments			37.811049 °	37.811049 °	
				-121.325451 °	-121.325451 °	
DWR ID	DWR_RD0544_01_s_2016_124					
Comment Code						
TR : Tree or limb						
Inspector Comment

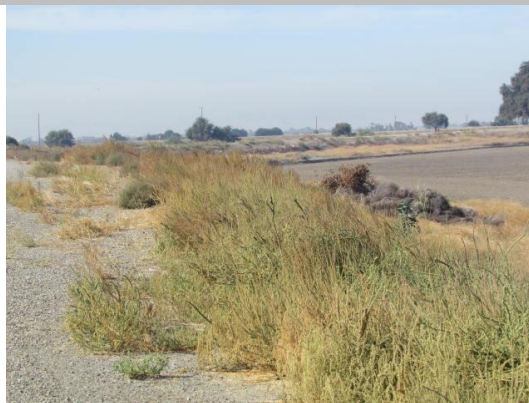
Photo 1 of 2 : SP_2017_RD0544_109_3_20170316_00002.jpg

LM Start	0.03	Rating **	M	Issue No.	3
LM End	0.17	Issue Type +	Ma	Location *	LS
Category	Earthen Levee			GPS Latitude/Longitude	
				Start	End
Item	Vegetation			37.808603 °	37.808213 °
				-121.328719 °	-121.331241 °
DWR ID	DWR_RD0544_02_s_2012_3				
Comment Code					
V2 : Remove the wild growth other than native grasses from the levee slopes.					
Inspector Comment

Looking south at dense veg on landward slope and toe fall 2015.

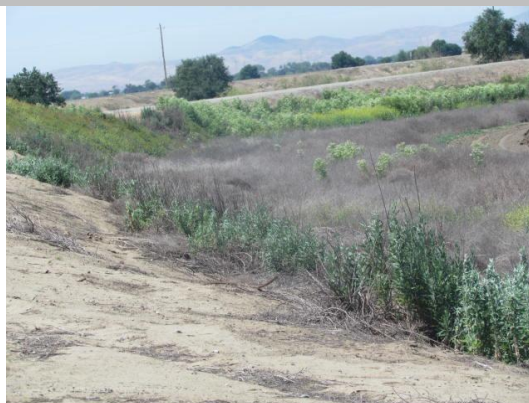
Photo 2 of 2 : SP_2017_RD0544_109_3_20170316_00003.jpg

Looking south at dense vegetation at landward toe spring 2014.

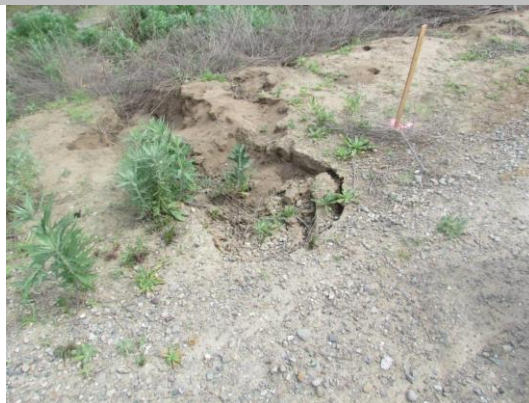
Photo 1 of 1 : SP_2017_RD0544_109_71_20170410_00088.jpg

LM Start	0.44	Rating **	U	Issue No.	71
LM End	0.44	Issue Type +	Ma	Location *	LS
Category	Earthen Levee			GPS Latitude/Longitude	
				Start	End
Item	Erosion / Bank Caving			37.810388 °	37.810388 °
				-121.334977 °	-121.334977 °
DWR ID	DWR_RD0544_02_s_2017_71				
Comment Code					
Inspector Comment					
Landside erosion due to runoff.

Looking northwest at runoff erosion on landward shoulder and slope.

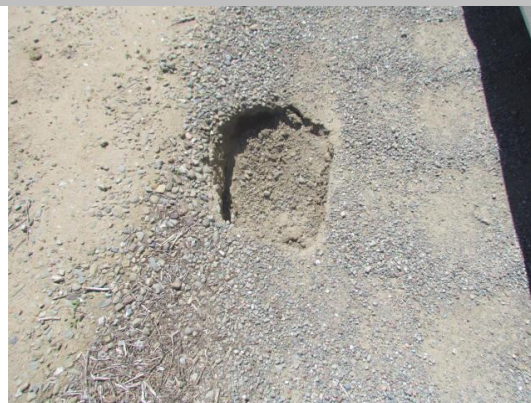
Photo 1 of 1 : SP_2017_RD0544_109_46_20170316_00037.jpg

LM Start	0.64	Rating **	U	Issue No.	46
LM End	0.64	Issue Type +	Ma	Location *	LS
Category	Earthen Levee			GPS Latitude/Longitude	
				Start	End
Item	Erosion / Bank Caving			37.813197 °	37.813197 °
				-121.335055 °	-121.335055 °
DWR ID	DWR_RD0544_02_s_2015_46				
Comment Code					
E1 : Note and monitor erosion site.					
Inspector Comment					
Depression greater than one inch deep and greater that three inches on landward shoulder

Looking at depression on landward shoulder.

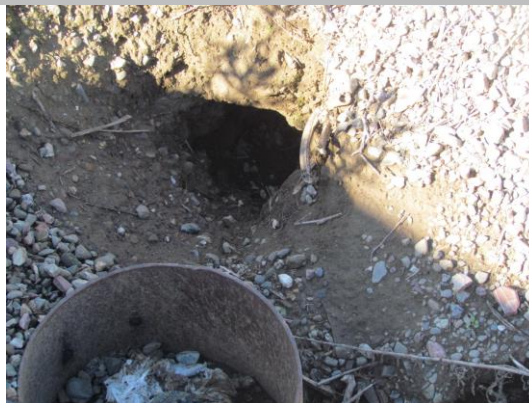
Photo 1 of 6 : SP_2017_RD0544_109_8_20170316_00007.jpg

LM Start	0.78	Rating **	U	Issue No.	8 (cont)
LM End	0.78	Issue Type +	Ma	Location *	WS

Looking at hole next to siphon on waterward shoulder. (Fall 2016)

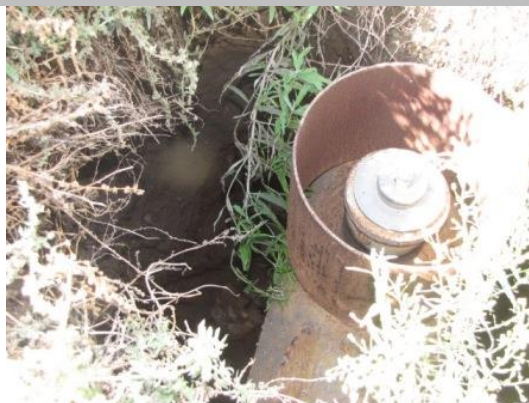
Photo 2 of 6 : SP_2017_RD0544_109_8_20170316_00008.jpg

Looking at caving around 10" siphon pipe on waterside shoulder.

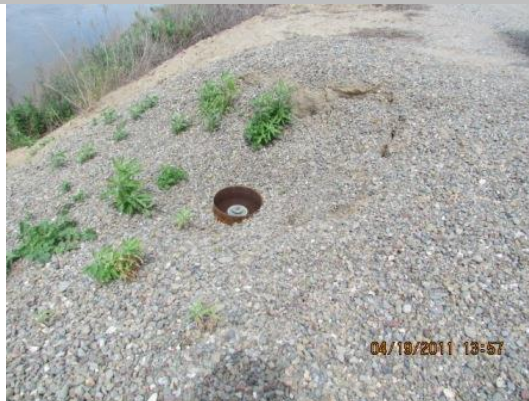
Photo 3 of 6 : SP_2017_RD0544_109_8_20170316_00009.jpg

Looking south at depression greater than 6" on waterside shoulder.

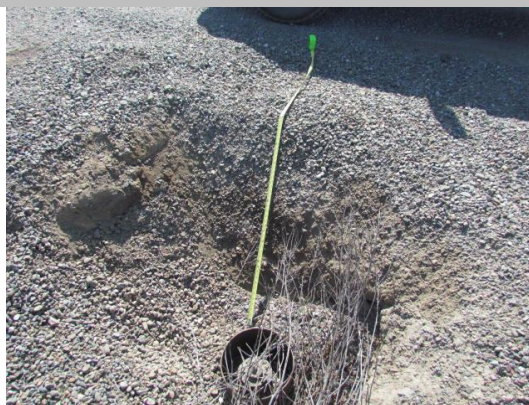
Photo 5 of 6 : SP_2017_RD0544_109_8_20170316_00011.jpg

Looking west at caving around siphon on waterside shoulder. (Spring 2012)

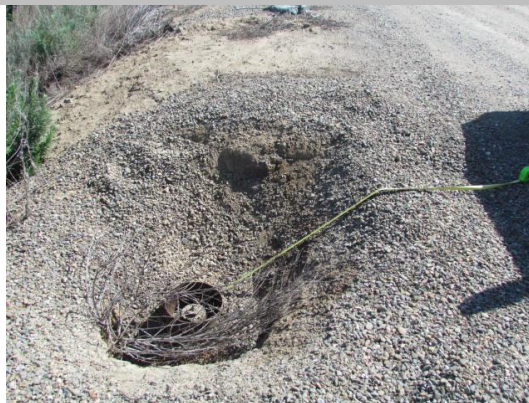
Photo 6 of 6 : SP_2017_RD0544_109_8_20170316_00012.jpg

Looking south at caving around siphon on waterside shoulder. (Spring 2012)

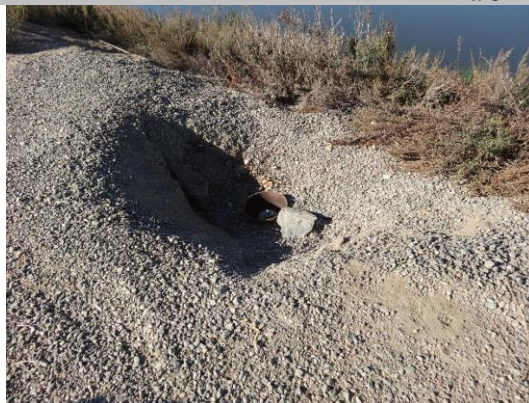
Photo 1 of 3 : UCIP_SP_2017_51382_44882.jpg

FS_ID:51382
DS_ID:22665
EP_NO: N/A
Repair Type: Urgent
Crossing Status: Found
UCIP Comments: 12/22/2016: Same as last inspection. Suspect siphon breaker is leaking due to depression around it. Two giant rodent holes through WS slope at siphon breaker. Siphon breaker is silted in. (K. Fazel - UCIP)10/31/2013:- 8 ft X 7 ft X 4 ft depression around siphon breaker on waterside slope.- no pipe visible on waterside due to dense vegetation.- electric conduit and service pole on landside. (P. Amatya - DWR)
FIELD_STRUCT_DESC: 12-inch steel drainage pipe through the levee, 4 feet below the crown. Pump in drain ditch off the landside (LS) toe. Siphon breaker on the waterside (WS) slope. [Additional Reference(s): DWR Levee Log, 2005].
FS Date: 12/22/2016

WS view: depression on levee slope around siphon breaker.

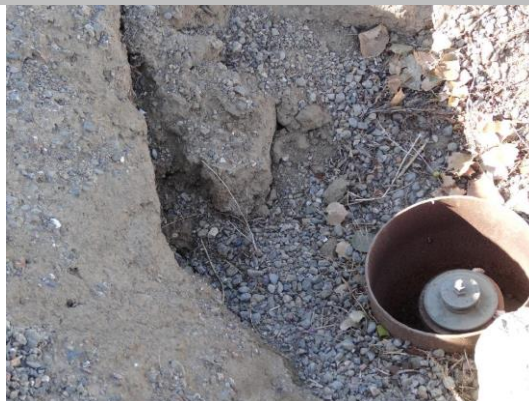
Photo 2 of 3 : UCIP_SP_2017_51382_44881.jpg

WS view: depression on levee slope around siphon breaker. Siphon breaker in steel pipe riser.

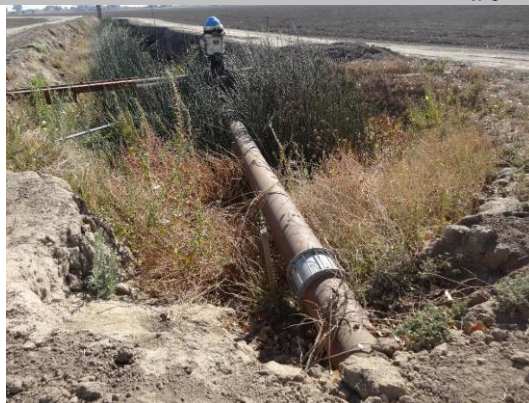
Photo 3 of 3 : UCIP_SP_2017_51382_44880.jpg

LS view: pump on timber support in drainage ditch. About 150 ft from levee center.

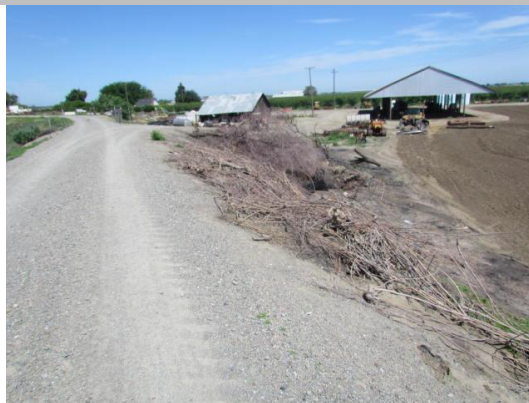
Photo 1 of 1 : SP_2017_RD0544_109_20_20170316_00027.jpg

LM Start	1.12	Rating **	U	Issue No.	20
LM End	1.12	Issue Type +	En	Location *	LS
Category	Earthen Levee			GPS Latitude/Longitude	
				Start	End
Item	Encroachments			37.819530 °	37.819530 °
				-121.333827 °	-121.333827 °
DWR ID	DWR_RD0544_02_s_2012_20				
Comment Code					
PR : Prunings					
Inspector Comment					
Landowner is stock piling prunings on landward slope and toe.

Looking southwest at pruning piles on landward slope.

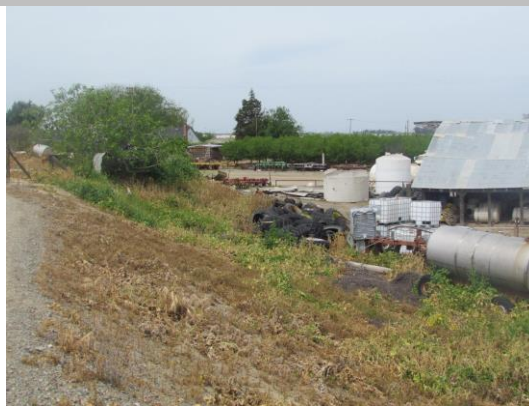
Photo 1 of 2 : SP_2017_RD0544_109_25_20170410_00089.jpg

LM Start	1.13	Rating **	U	Issue No.	25
LM End	1.19	Issue Type +	En	Location *	LS
Category	Earthen Levee			GPS Latitude/Longitude	
				Start	End
Item	Encroachments			37.819560 °	37.820083 °
				-121.333893 °	-121.334812 °
DWR ID	DWR_RD0544_02_s_2012_25				
Comment Code					
DE : Debris					
Inspector Comment

Looking south at farm equipment stored on landward shoulder and slope.

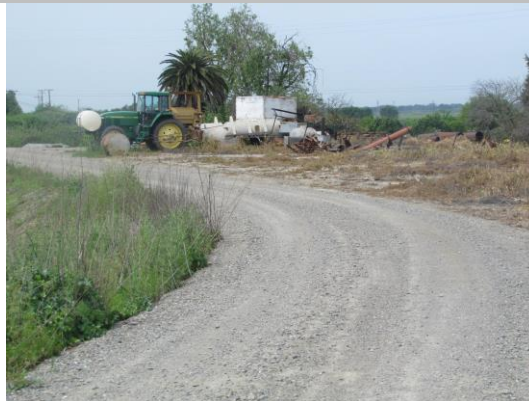
Photo 2 of 2 : SP_2017_RD0544_109_25_20170410_00090.jpg

LM Start	1.13	Rating **	U	Issue No.	25 (cont)
LM End	1.19	Issue Type +	En	Location *	LS

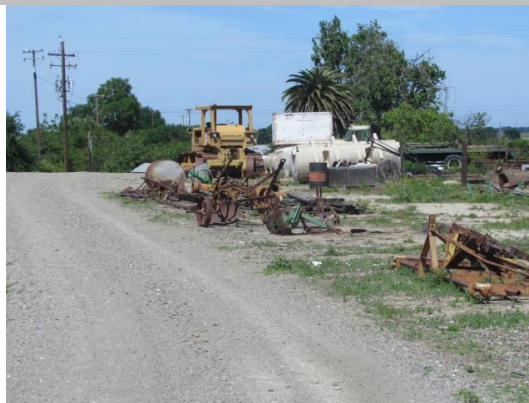
Photo 1 of 4 : SP_2017_RD0544_109_18_20170316_00023.jpg

LM Start	1.15	Rating **	M	Issue No.	18
LM End	1.22	Issue Type +	En	Location *	LS
Category	Earthen Levee			GPS Latitude/Longitude	
				Start	End
Item	Encroachments			37.819830 °	37.820235 °
				-121.334233 °	-121.335268 °
DWR ID	DWR_RD0544_02_s_2012_18				
Comment Code					
AV : Abandoned vehicles					
Inspector Comment					
Vehicles and farm equipment stored on landside for several years. Area is defined a oversized levee. Landowner is in the process of moving items from landward shoulder.

Looking southwest at farm equipment stored on landward landing. (spring 2016)

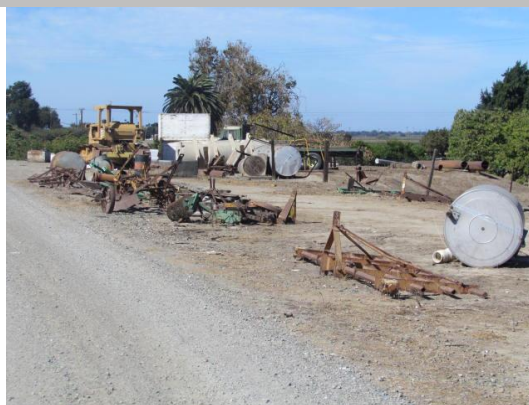
Photo 2 of 4 : SP_2017_RD0544_109_18_20170316_00024.jpg

Looking southwest at equipment stored on landward shoulder. (spring 2015)

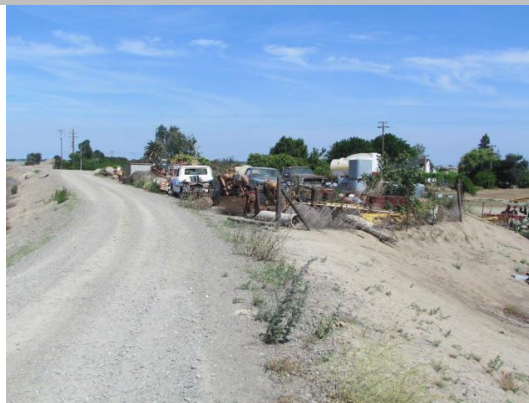
Photo 3 of 4 : SP_2017_RD0544_109_18_20170316_00025.jpg

Looking southwest at vehicles and farm equipment stored on landside landing. (spring 2014)

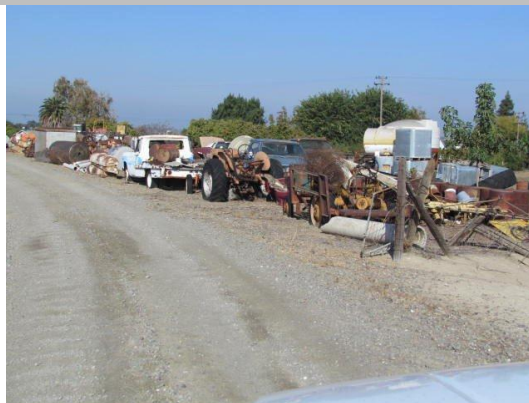
Photo 4 of 4 : SP_2017_RD0544_109_18_20170316_00026.jpg

LM Start	1.15	Rating **	M	Issue No.	18 (cont)	
LM End	1.22	Issue Type +	En	Location *	LS	
Category	Earthen Levee			GPS Latitude/Longitude		
				Start		End
Item	Encroachments			37.819830 °		37.820235 °
				-121.334233 °		-121.335268 °
DWR ID	DWR_RD0544_02_s_2012_18					
Comment Code						
AV : Abandoned vehicles						
Inspector Comment						
Vehicles and farm equipment stored on landside for several years. Area is defined a oversized levee. Landowner is in the process of moving items from landward shoulder.

Looking southwest at farm equipment, vehicles, and other items stored on landside landing. (spring 2013)

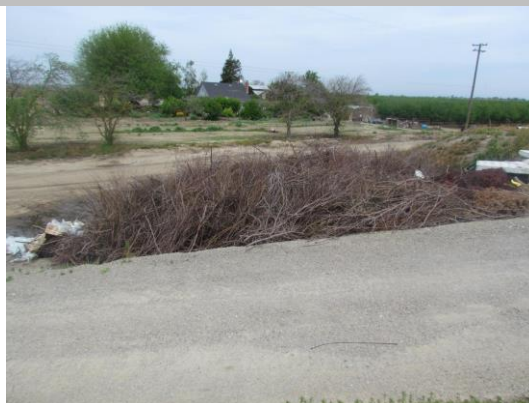
Photo 1 of 1 : SP_2017_RD0544_109_72_20170410_00091.jpg

LM Start	1.23	Rating **	U	Issue No.	72
LM End	1.23	Issue Type +	Ma	Location *	LS
Category	Earthen Levee			GPS Latitude/Longitude	
				Start	End
Item	Encroachments			37.820288 °	37.820288 °
				-121.335410 °	-121.335410 °
DWR ID	DWR_RD0544_02_s_2017_72				
Comment Code					
PR : Prunings					
Inspector Comment

Looking west at large pruning pile at landward toe.

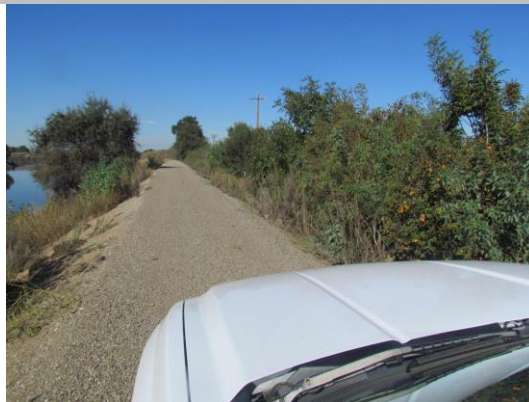
Photo 1 of 2 : SP_2017_RD0544_109_49_20170316_00038.jpg

LM Start	1.30	Rating **	U	Issue No.	49
LM End	1.40	Issue Type +	Ma	Location *	WS
Category	Earthen Levee			GPS Latitude/Longitude	
				Start	End
Item	Vegetation			37.820767 °	37.821582 °
				-121.336611 °	-121.338102 °
DWR ID	DWR_RD0544_02_f_2014_49				
Comment Code					
V2 : Remove the wild growth other than native grasses from the levee slopes.					
Inspector Comment					
Tobacco plants on waterward slope.

Looking southwest at dense veg on landward slope. (Fall 2016)

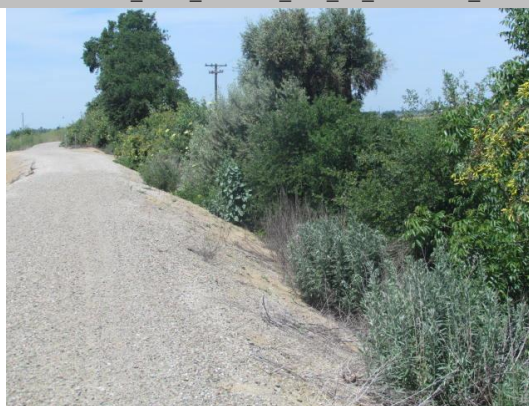
Photo 2 of 2 : SP_2017_RD0544_109_49_20170316_00039.jpg

LM Start	1.30	Rating **	U	Issue No.	49 (cont)	
LM End	1.40	Issue Type +	Ma	Location *	WS	
Category	Earthen Levee			GPS Latitude/Longitude		
				Start		End
Item	Vegetation			37.820767 °		37.821582 °
				-121.336611 °		-121.338102 °
DWR ID	DWR_RD0544_02_f_2014_49					
Comment Code						
V2 : Remove the wild growth other than native grasses from the levee slopes.						
Inspector Comment						
Tobacco plants on waterward slope.

Looking southwest at dense vegetation on landward slope and toe.

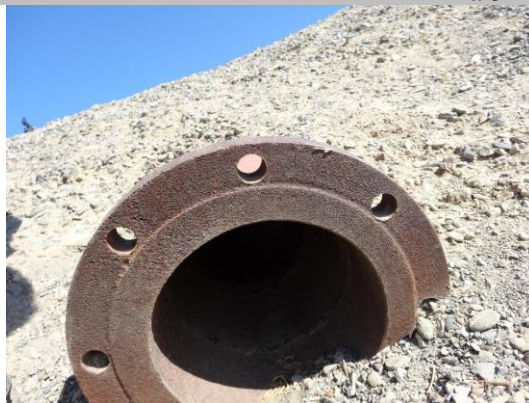
Photo 1 of 3 : UCIP_SP_2017_46674_44890.jpg

FS_ID:46674
DS_ID:22668
EP_NO: N/A
Repair Type: Non-Urgent
Crossing Status: Found
UCIP Comments: - slope erosion on landside.
FIELD_STRUCT_DESC: 8-inch pipe through the levee, 3.5 ft below the crown; open on both ends. Steel pipe riser on LS but not sure whether it is connected to the pipe.
FS Date: 10/31/2013

WS view: steel pipe on levee slope with opened end.

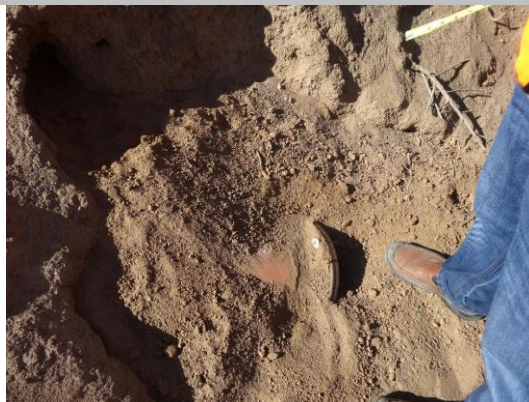
Photo 2 of 3 : UCIP_SP_2017_46674_44889.jpg

LS view: steel pipe on levee slope with opened end. Levee slope erosion around the pipe.

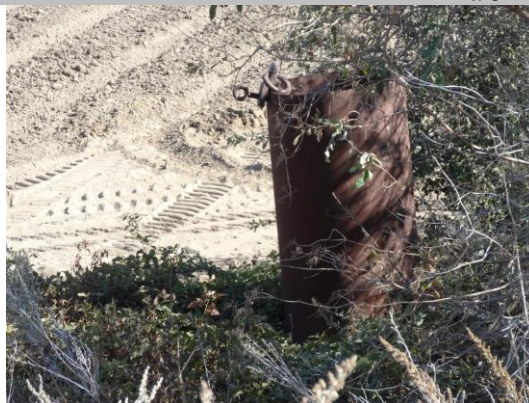
Photo 3 of 3 : UCIP_SP_2017_46674_44888.jpg

LM Start	1.38	Rating **	M	Issue No.	81 (cont)
LM End	1.38	Issue Type +	En	Location *	WS
Category	Supplemental			GPS Latitude/Longitude	
				Start	End
Item	DWR UCIP Field Study			37.821380 °	37.821380 °
				-121.337835 °	-121.337835 °
DWR ID					
Comment Code					
Inspector Comment					
FS_ID:46674					
DS_ID:22668					
EP_NO: N/A					
Repair Type: Non-Urgent					
Crossing Status: Found					
UCIP Comments: - slope erosion on landside.					
FIELD_STRUCT_DESC: 8-inch pipe through the levee, 3.5 ft below the crown; open on both ends. Steel pipe riser on LS but not sure whether it is connected to the pipe.					
FS Date: 10/31/2013

LS view: steel pipe riser off the levee toe.

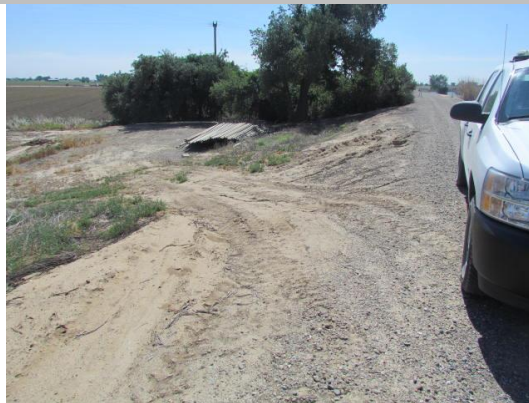
Photo 2 of 2 : SP_2017_RD0544_109_22_20170316_00029.jpg

LM Start	1.42	Rating **	M	Issue No.	22
LM End	1.42	Issue Type +	Ma	Location *	LS
Category	Earthen Levee			GPS Latitude/Longitude	
				Start	End
Item	Slope Stability			37.821697 °	37.821697 °
				-121.338397 °	-121.338397 °
DWR ID	DWR_RD0544_02_s_2012_22				
Comment Code					
S3 : Repair the levee slope damaged by vehicle traffic and prevent access where possible.					
Inspector Comment					
Damage caused by vehicle traffic.

Looking northwest at slope damage caused by vehicle traffic.

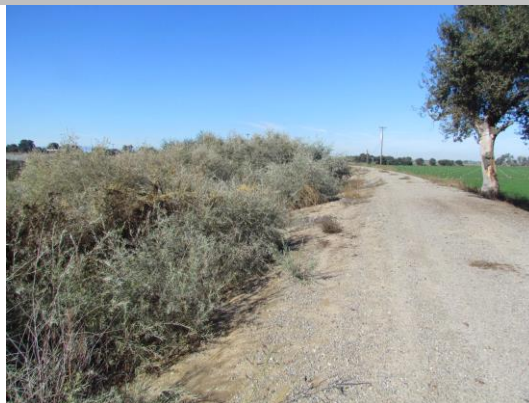
Photo 1 of 1 : SP_2017_RD0544_109_66_20170316_00051.jpg

LM Start	1.44	Rating **	U	Issue No.	66
LM End	1.46	Issue Type +	Ma	Location *	WS
Category	Earthen Levee			GPS Latitude/Longitude	
				Start	End
Item	Vegetation			37.821907 °	37.822098 °
				-121.338725 °	-121.338985 °
DWR ID	DWR_RD0544_02_f_2016_66				
Comment Code					
V2 : Remove the wild growth other than native grasses from the levee slopes.					
Inspector Comment					
Dense willows on waterward slope.

Looking southeast at dense veg on waterward slope.

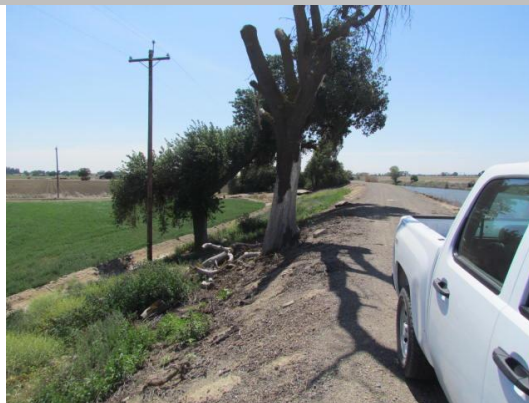
Photo 1 of 1 : SP_2017_RD0544_109_23_20170316_00030.jpg

LM Start	1.46	Rating **	M	Issue No.	23
LM End	1.46	Issue Type +	Ma	Location *	LS
Category	Earthen Levee			GPS Latitude/Longitude	
				Start	End
Item	Encroachments			37.822082 °	37.822082 °
				-121.338932 °	-121.338932 °
DWR ID	DWR_RD0544_02_s_2012_23				
Comment Code					
TR : Tree or limb					
Inspector Comment					
Dead tree and limbs should be removed from landside shoulder and slope.

Looking north at dead tree and tree limbs on landside shoulder and slope.

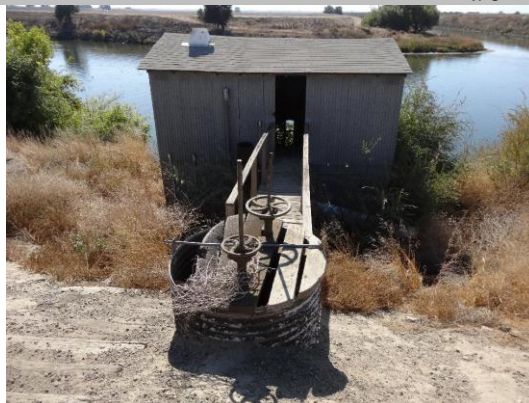
Photo 1 of 3 : UCIP_SP_2017_24288_42947.jpg

LM Start	1.51	Rating **	M	Issue No.	82
LM End	1.51	Issue Type +	En	Location *	LS
Category	Supplemental			GPS Latitude/Longitude	
				Start	End
Item	DWR UCIP Field Study			37.822415 °	37.822415 °
				-121.339699 °	-121.339699 °
DWR ID					
Comment Code					
Inspector Comment					
FS_ID:24288 DS_ID:22669 EP_NO: N/A Repair Type: Non-Urgent Crossing Status: Found UCIP Comments: - two pumps with 16" steel pipe and an abandoned pump with 10" pipe inside pump house.- CMP riser cover needs repair. - electric conduits on waterside and power pole on landside. FIELD_STRUCT_DESC: 24-inch steel pipe through the levee, 14.0 feet below the crown. Pump in pump house on the waterward berm. Slide gate in CM pipe riser on the waterward slope. Two CM cutoff walls. Distribution box and power pole on landward toe. O&M Manual SJR 007, April 1964. FS Date: 10/31/2013

WS view: slide gate in CMP riser, walkway, and pump house on levee slope.

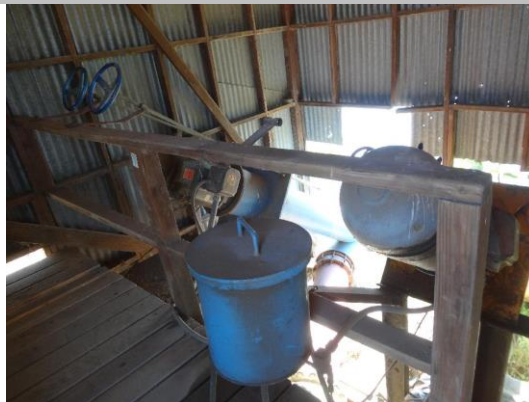
Photo 2 of 3 : UCIP_SP_2017_24288_42946.jpg

WS view: two pumps discharges water into CMP riser on levee slope.

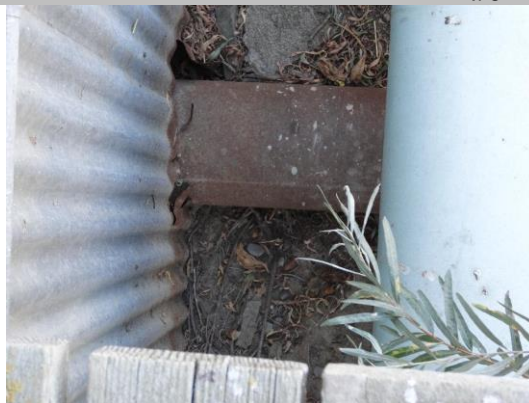
Photo 3 of 3 : UCIP_SP_2017_24288_42945.jpg

LM Start	1.51	Rating **	M	Issue No.	82 (cont)
LM End	1.51	Issue Type +	En	Location *	LS
Category	Supplemental			GPS Latitude/Longitude	
				Start	End
Item	DWR UCIP Field Study			37.822415 °	37.822415 °
				-121.339699 °	-121.339699 °
DWR ID					
Comment Code					
Inspector Comment					
FS_ID:24288 DS_ID:22669 EP_NO: N/A Repair Type: Non-Urgent Crossing Status: Found UCIP Comments: - two pumps with 16" steel pipe and an abandoned pump with 10" pipe inside pump house.- CMP riser cover needs repair. - electric conduits on waterside and power pole on landside. FIELD_STRUCT_DESC: 24-inch steel pipe through the levee, 14.0 feet below the crown. Pump in pump house on the waterward berm. Slide gate in CM pipe riser on the waterward slope. Two CM cutoff walls. Distribution box and power pole on landward toe. O&M Manual SJR 007, April 1964. FS Date: 10/31/2013

WS view: abandoned 10" steel pipe daylights on levee slope.

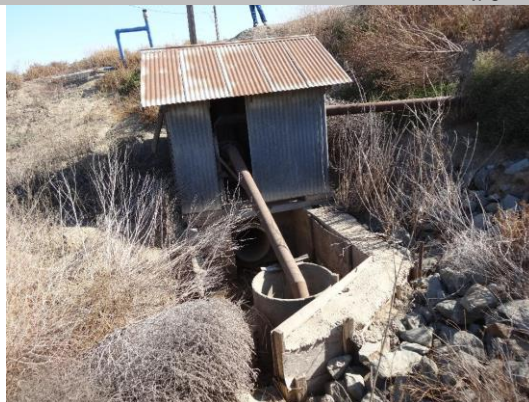
Photo 1 of 3 : UCIP_SP_2017_24907_44895.jpg

LM Start	1.52	Rating **	M	Issue No.	83
LM End	1.52	Issue Type +	En	Location *	LS
Category	Supplemental			GPS Latitude/Longitude	
				Start	End
Item	DWR UCIP Field Study			37.822445 °	37.822445 °
				-121.339910 °	-121.339910 °
DWR ID					
Comment Code					
Inspector Comment					
FS_ID:24907					
DS_ID:24716					
EP_NO: N/A					
Repair Type: Non-Urgent					
Crossing Status: Found					
UCIP Comments: No pipe and appurtenances found on waterside. Looks abandoned.					
FIELD_STRUCT_DESC: An abandoned 8-inch steel pipe through levee. Pump house on landside toe. Air vent in CMP riser on landside shoulder. Outlet on waterside not visible. No positive closure. Appears abandoned.					
FS Date: 10/31/2013

LS view: pipe, pump house, and appurtenances on levee slope.

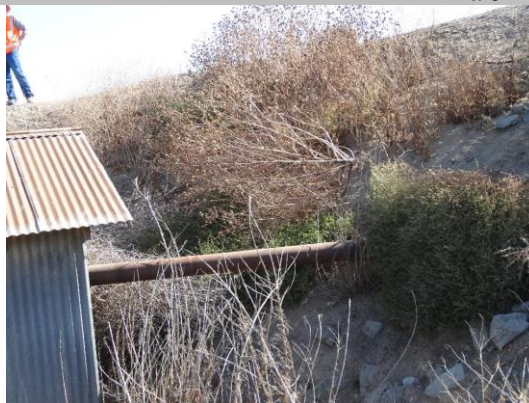
Photo 2 of 3 : UCIP_SP_2017_24907_44894.jpg

LM Start	1.52	Rating **	M	Issue No.	83 (cont)	
LM End	1.52	Issue Type +	En	Location *	LS	
Category	Supplemental			GPS Latitude/Longitude		
				Start	End	
Item	DWR UCIP Field Study			37.822445 °	37.822445 °	
				-121.339910 °	-121.339910 °	
DWR ID						
Comment Code						
Inspector Comment						
FS_ID:24907						
DS_ID:24716						
EP_NO: N/A						
Repair Type: Non-Urgent						
Crossing Status: Found						
UCIP Comments: No pipe and appurtenances found on waterside.Looks abandoned.						
FIELD_STRUCT_DESC: An abandoned 8-inch steelpipe through levee. Pump house on landside toe. Air vent in CMP riser on landside shoulder. Outlet on waterside not visible. No positive closure. Appears abandoned.						
FS Date: 10/31/2013

LS view: pipe daylights on levee slope.

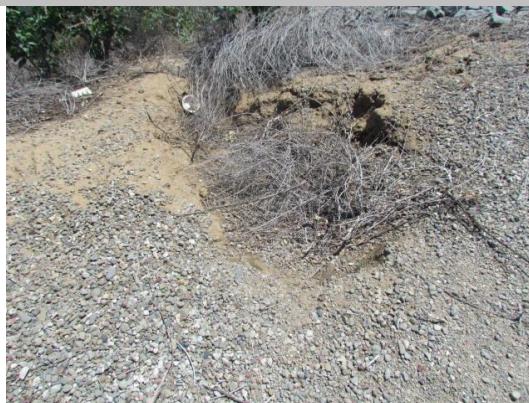
Photo 1 of 2 : SP_2017_RD0544_109_38_20170316_00034.jpg

LM Start	1.86	Rating **	U	Issue No.	38
LM End	1.86	Issue Type +	Ma	Location *	WS
Category	Earthen Levee			GPS Latitude/Longitude	
				Start	End
Item	Erosion / Bank Caving			37.817983 °	37.817983 °
				-121.341682 °	-121.341682 °
DWR ID	DWR_RD0544_02_s_2015_38				
Comment Code					
E1 : Note and monitor erosion site.					
Inspector Comment					
Erosion/Caving on waterward shoulder and slope 18" x 6" x 15'.

Looking southeast at erosion/caving on waterward slope.

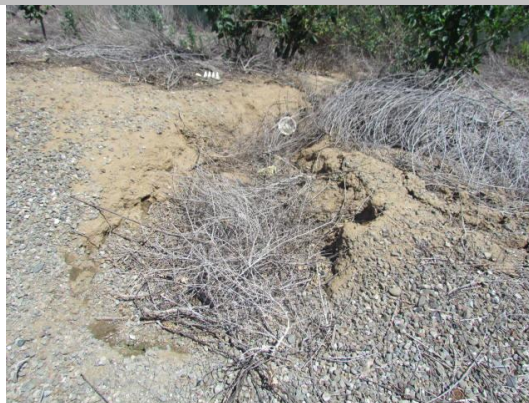
Photo 2 of 2 : SP_2017_RD0544_109_38_20170316_00035.jpg

LM Start	1.86	Rating **	U	Issue No.	38 (cont)
LM End	1.86	Issue Type +	Ma	Location *	WS

Looking east at erosion/caving on waterward slope.

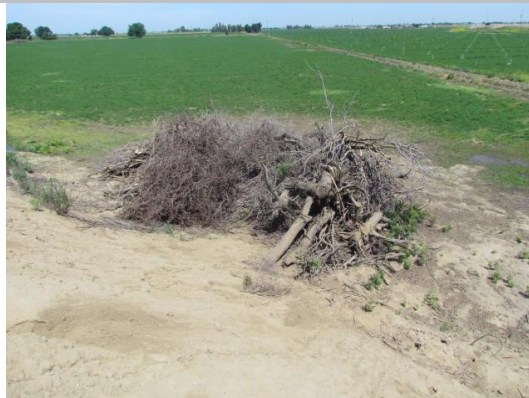
Photo 1 of 1 : SP_2017_RD0544_109_57_20170316_00045.jpg

LM Start	2.02	Rating **	A/W	Issue No.	57
LM End	2.02	Issue Type +	Ma	Location *	LS
Category	Earthen Levee			GPS Latitude/Longitude	
				Start	End
Item	Encroachments			37.818853 °	37.818853 °
				-121.343473 °	-121.343473 °
DWR ID	DWR_RD0544_02_s_2015_57				
Comment Code					
PR : Prunings					
Inspector Comment					
Large pruning pile at landward toe.

Looking west at pruning pile at landward toe.(Spring 2015)

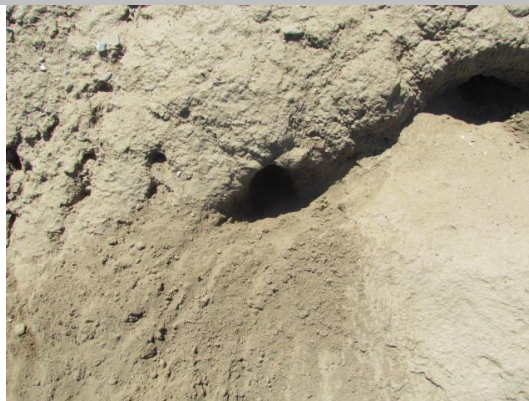
Photo 1 of 1 : SP_2017_RD0544_109_58_20170316_00046.jpg

LM Start	2.02	Rating **	U	Issue No.	58
LM End	2.09	Issue Type +	Ma	Location *	LS
Category	Earthen Levee			GPS Latitude/Longitude	
				Start	End
Item	Animal Control			37.818853 °	37.819493 °
				-121.343473 °	-121.344545 °
DWR ID	DWR_RD0544_02_s_2015_58				
Comment Code					
A1 : Exterminate rodents and backfill and compact or grout burrows.					
Inspector Comment					
Several rodent holes within reach on landward slope.

Looking at typical rodent holes on landward slope.

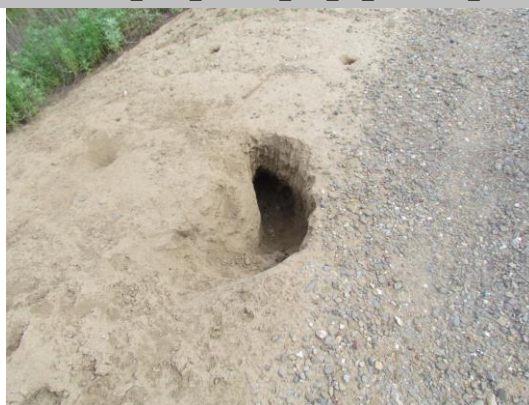
Photo 1 of 1 : SP_2017_RD0544_109_73_20170410_00092.jpg

LM Start	2.02	Rating **	U	Issue No.	73
LM End	2.02	Issue Type +	Ma	Location *	LS
Category	Earthen Levee			GPS Latitude/Longitude	
				Start	End
Item	Animal Control			37.818833 °	37.818833 °
				-121.343547 °	-121.343547 °
DWR ID	DWR_RD0544_02_s_2017_73				
Comment Code					
A3 : No rodents visible, but rodent burrows visible; need to backfill and compact or grout burrows.					
Inspector Comment

Looking west at large rodent hole on landward shoulder and slope.

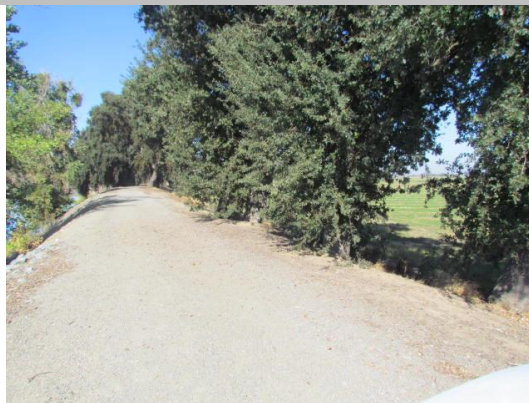
Photo 1 of 1 : SP_2017_RD0544_109_59_20170316_00047.jpg

LM Start	2.12	Rating **	U	Issue No.	59
LM End	2.12	Issue Type +	Ma	Location *	LS
Category	Earthen Levee			GPS Latitude/Longitude	
				Start	End
Item	Trim / Thin Trees			37.819738 °	37.819738 °
				-121.344922 °	-121.344922 °
DWR ID	DWR_RD0544_02_s_2015_59				
Comment Code					
T1 : Trim trees to at least five feet above ground level.					
Inspector Comment					
Untrimmed trees on landward shoulder and slope.

Looking southwest at untrimmed trees on landward slope and toe fall 2015.

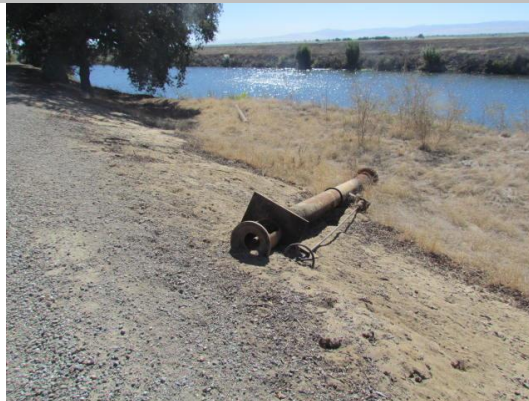
Photo 1 of 1 : SP_2017_RD0544_109_50_20170316_00040.jpg

LM Start	2.21	Rating **	M	Issue No.	50
LM End	2.21	Issue Type +	Ma	Location *	WS
Category	Earthen Levee			GPS Latitude/Longitude	
				Start	End
Item	Encroachments			37.820646 °	37.820646 °
				-121.346014 °	-121.346014 °
DWR ID	DWR_RD0544_02_f_2014_50				
Comment Code					
GA : Garbage					
Inspector Comment					
Discarded intake pipe on waterward slope.

Looking northwest at pipe on waterward slope.

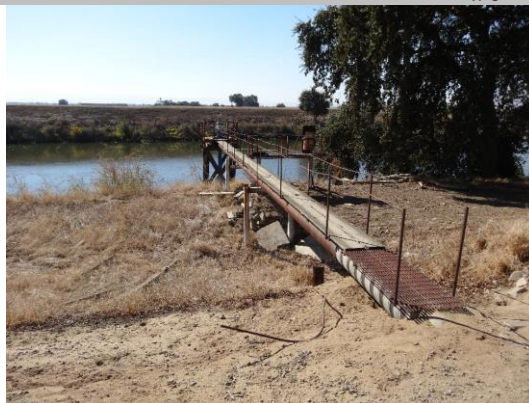
Photo 1 of 3 : UCIP_SP_2017_41731_42954.jpg

LM Start	2.21	Rating **	M	Issue No.	84
LM End	2.21	Issue Type +	En	Location *	WS
Category	Supplemental			GPS Latitude/Longitude	
				Start	End
Item	DWR UCIP Field Study			37.820694 °	37.820694 °
				-121.346067 °	-121.346067 °
DWR ID					
Comment Code					
Inspector Comment					
FS_ID:41731 DS_ID:22675 EP_NO: N/A Repair Type: Non-Urgent Crossing Status: Found UCIP Comments: - soil erosion on landside slope.- new pump and pipe (according to the owner- three months old)- electric conduit through levee, service pole on landside. FIELD_STRUCT_DESC: 16-inch steel pipe and electric conduit through the levee, 3.0 feet below the crown. Pump on pile structure in the stream. Pressure breaker on the landward slope. Pipe exposed on both slopes and the berm. O&M Manual SJR 007, April 1964. FS Date: 10/31/2013

WS view: pipe, walkway, and pump on pile structure.

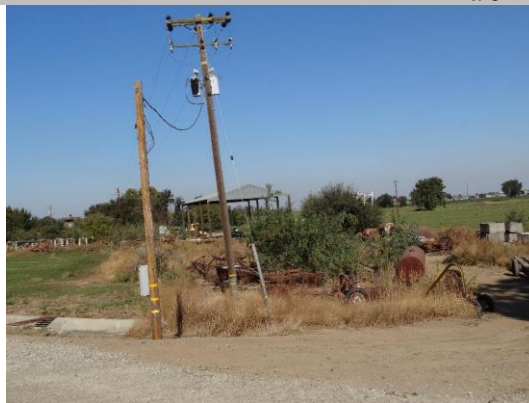
Photo 3 of 3 : UCIP_SP_2017_41731_42957.jpg

LM Start	2.21	Rating **	M	Issue No.	84 (cont)	
LM End	2.21	Issue Type +	En	Location *	WS	
Category	Supplemental			GPS Latitude/Longitude		
				Start		End
Item	DWR UCIP Field Study			37.820694 °		37.820694 °
				-121.346067 °		-121.346067 °
DWR ID						
Comment Code						
Inspector Comment						
FS_ID:41731 DS_ID:22675 EP_NO: N/A Repair Type: Non-Urgent Crossing Status: Found UCIP Comments: - soil erosion on landside slope.- new pump and pipe (according to the owner- three months old)- electric conduit through levee, service pole on landside. FIELD_STRUCT_DESC: 16-inch steel pipe and electric conduit through the levee, 3.0 feet below the crown. Pump on pile structure in the stream. Pressure breaker on the landward slope. Pipe exposed on both slopes and the berm. O&M Manual SJR 007, April 1964. FS Date: 10/31/2013

LS view: service pole on levee slope.

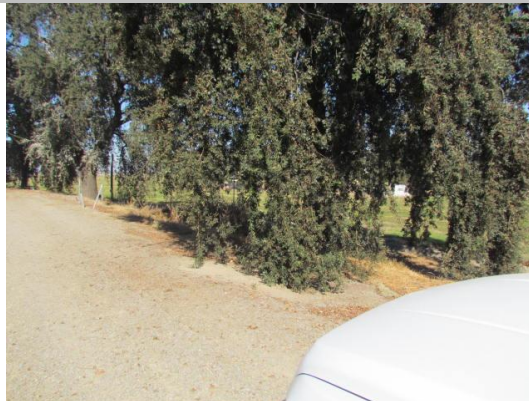
Photo 1 of 1 : SP_2017_RD0544_109_61_20170316_00048.jpg

LM Start	2.28	Rating **	U	Issue No.	61
LM End	2.28	Issue Type +	Ma	Location *	LS
Category	Earthen Levee			GPS Latitude/Longitude	
				Start	End
Item	Trim / Thin Trees			37.821473 °	37.821473 °
				-121.346860 °	-121.346860 °
DWR ID	DWR_RD0544_02_s_2015_61				
Comment Code					
T1 : Trim trees to at least five feet above ground level.					
Inspector Comment					
Untrimmed tree on landward shoulder.

Looking west at untrimmed trees on landward slope fall 2015.

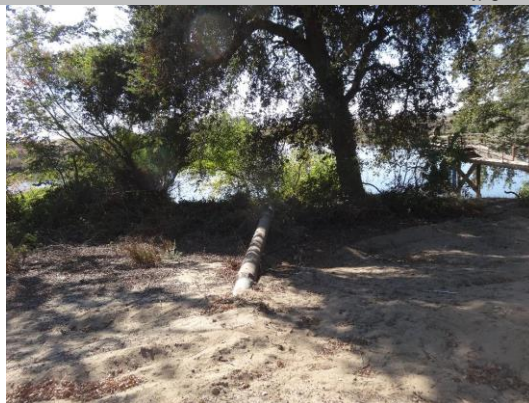
Photo 1 of 3 : UCIP_SP_2017_24293_42965.jpg

LM Start	2.29	Rating **	M	Issue No.	85
LM End	2.29	Issue Type +	En	Location *	LS
Category	Supplemental			GPS Latitude/Longitude	
				Start	End
Item	DWR UCIP Field Study			37.821628 °	37.821628 °
				-121.347016 °	-121.347016 °
DWR ID					
Comment Code					
Inspector Comment					
FS_ID:24293 DS_ID:22676 EP_NO: N/A Repair Type: Non-Urgent Crossing Status: Found UCIP Comments: Pump not found on the landward side. FIELD_STRUCT_DESC: 10-inch steel pipe through the levee, 3.0 feet below the crown. No flap gate on the waterward end. Air vent on landside. O&M Manual SJR 007, April 1964. FS Date: 10/31/2013

WS view: exposed steel pipe on berm.

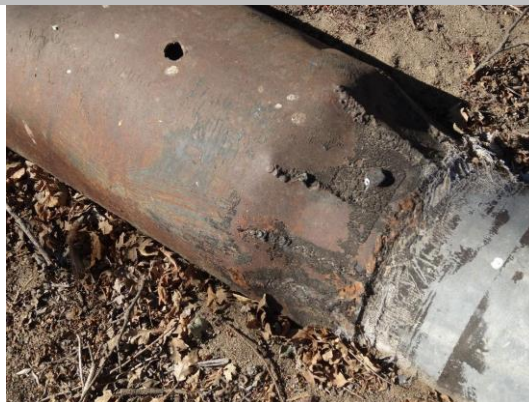
Photo 2 of 3 : UCIP_SP_2017_24293_42964.jpg

WS view: 12" steel pipe connected to 10" pipe. Holes on pipe top found.

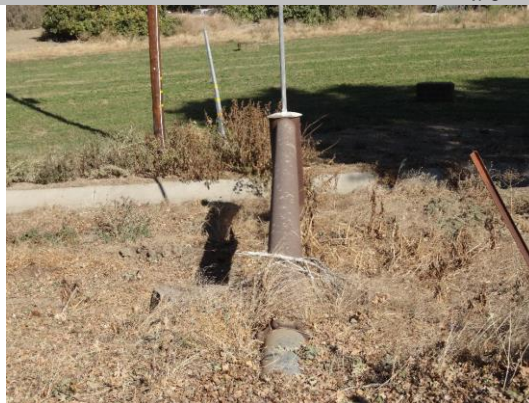
Photo 3 of 3 : UCIP_SP_2017_24293_42966.jpg

LM Start	2.29	Rating **	M	Issue No.	85 (cont)
LM End	2.29	Issue Type +	En	Location *	LS
Category	Supplemental			GPS Latitude/Longitude	
				Start	End
Item	DWR UCIP Field Study			37.821628 °	37.821628 °
				-121.347016 °	-121.347016 °
DWR ID					
Comment Code					
Inspector Comment					
FS_ID:24293 DS_ID:22676 EP_NO: N/A Repair Type: Non-Urgent Crossing Status: Found UCIP Comments: Pump not found on the landward side. FIELD_STRUCT_DESC: 10-inch steel pipe through the levee, 3.0 feet below the crown. No flap gate on the waterward end. Air vent on landside. O&M Manual SJR 007, April 1964. FS Date: 10/31/2013

LS view: exposed steel pipe and air vent on levee berm. No pump found.

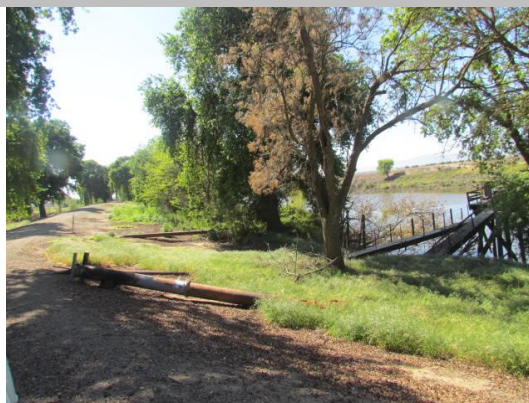
Photo 1 of 1 : SP_2017_RD0544_109_51_20170316_00041.jpg

LM Start	2.31	Rating **	M	Issue No.	51
LM End	2.31	Issue Type +	Ma	Location *	WS
Category	Earthen Levee			GPS Latitude/Longitude	
				Start	End
Item	Encroachments			37.821757 °	37.821757 °
				-121.347181 °	-121.347181 °
DWR ID	DWR_RD0544_02_s_2014_51				
Comment Code					
PI : Pipe					
Inspector Comment					
Landowner repaired pump and replaced pipe and left pump shaft and pipe on waterward slope.

Looking north at old pump shaft and pipe on waterward slope.

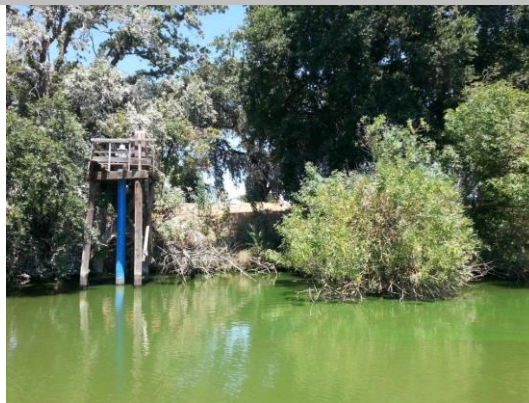
Photo 1 of 2 : SP_2017_RD0544_109_12_20170316_00017.jpg

LM Start	2.31	Rating **	M	Issue No.	12
LM End	2.31	Issue Type +	Ma	Location *	WS
Category	Supplemental			GPS Latitude/Longitude	
				Start	End
Item	DWR Erosion Survey			37.821763 °	37.821763 °
				-121.347275 °	-121.347275 °
DWR ID	DWR_RD0544_02_s_2017_12				
Comment Code					
Inspector Comment					
07/25/2016: No significant change observed.					
06/25/2015: No significant change observed.					
07/02/2014: No significant change observed.					
08/20/2013: No significant change observed.					
08/07/2012: The site was first reported in 2012 spring levee inspection report. The data were estimated as the site is underneath a irrigation pump station and inaccessible by boat or land survey. It's possible the pump station played a role in the erosion. [2016 Site ID:RD0544U02RM33.21]

Front view of the erosion site. View is partially blocked by the pump structure and vegetation at the site.

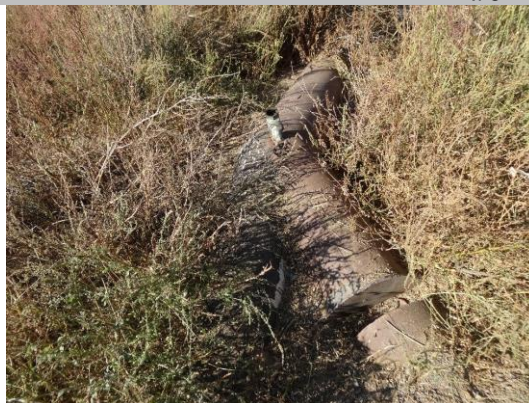
Photo 2 of 3 : UCIP_SP_2017_51381_42971.jpg

LM Start	2.61	Rating **	M	Issue No.	86 (cont)	
LM End	2.61	Issue Type +	En	Location *	WS	
Category	Supplemental			GPS Latitude/Longitude		
				Start		End
Item	DWR UCIP Field Study			37.818888 °		37.818888 °
				-121.350390 °		-121.350390 °
DWR ID						
Comment Code						
Inspector Comment						
FS_ID:51381						
DS_ID:22678						
EP_NO: 8625A						
Repair Type: Non-Urgent						
Crossing Status: Found						
UCIP Comments: - abandoned crossing. Needs proper						
abandonment.- pump removed. Pipe discontinued on landside.- pile						
structure in dilapalated condon.						
FIELD_STRUCT_DESC: 16-inch steel pipe through the levee, 7.0 feet						
below the crown. Pump mounted on pile structure in the stream. Siphon						
breaker on landward shoulder. Power pole on the landward slope. (App.						
No. 8625A - Irvin Muller) O&M Manual SJR 007, April 1964.						
FS Date: 10/31/2013

LS view: steel pipe cut out and discontinued (bottom).

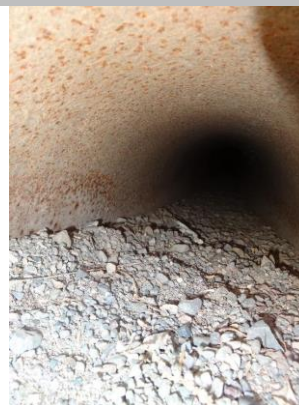
Photo 3 of 3 : UCIP_SP_2017_51381_42970.jpg

LS view: inside view of cut open pipe.

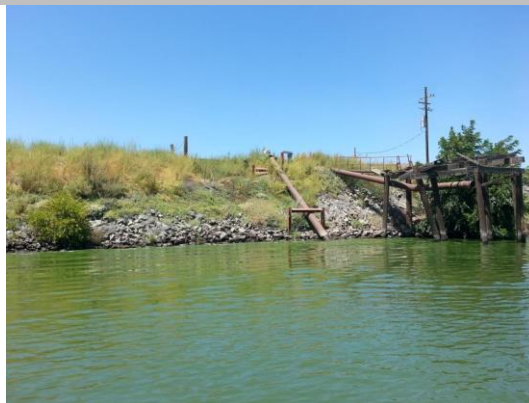
Photo 1 of 2 : SP_2017_RD0544_109_9_20170316_00013.jpg

LM Start	2.61	Rating **	U	Issue No.	9
LM End	2.61	Issue Type +	Ma	Location *	WS
Category	Supplemental			GPS Latitude/Longitude	
				Start	End
Item	DWR Erosion Survey			37.818861 °	37.818861 °
				-121.350400 °	-121.350400 °
DWR ID	DWR_RD0544_02_s_2017_9				
Comment Code					
Inspector Comment					
07/25/2016: No significant change observed.					
06/25/2015: The site was discovered during the boat survey. Irrigation pipe leakage caused the soil to sink at the upper levee shoulder. The lower part of the levee is protected by riprap rocks. The irrigation pump was operating at the site. [2016 Site ID:RD0544U02RM33]

Front view of the erosion site.

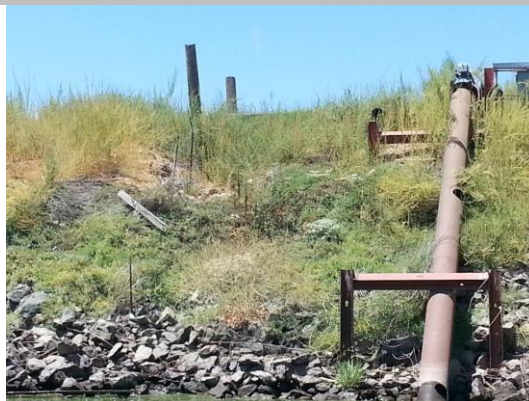
Photo 2 of 2 : SP_2017_RD0544_109_9_20170316_00014.jpg

Close view of the erosion. Vegetation around the site is visible.

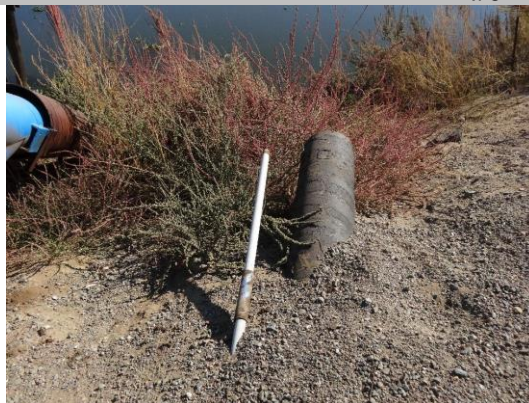
Photo 1 of 3 : UCIP_SP_2017_51380_42977.jpg

LM Start	2.61	Rating **	U	Issue No.	87
LM End	2.61	Issue Type +	En	Location *	WS
Category	Supplemental			GPS Latitude/Longitude	
				Start	End
Item	DWR UCIP Field Study			37.818860 °	37.818860 °
				-121.350428 °	-121.350428 °
DWR ID					
Comment Code					
Inspector Comment					
FS_ID:51380 DS_ID:24718 EP_NO: N/A Repair Type: Urgent Crossing Status: Found UCIP Comments: 12/22/2016: Pipe is open on both ends and requires either proper abandonment or flap gate and closure device. Crossing has been upgraded from Non-Urgent to Urgent. (K. Fazel - UCIP)10/31/2013:- needs proper abandonment or closer of pipe end. (P. Amatya - DWR) FIELD_STRUCT_DESC: 14-inch steel pipe through levee, 2 feet below the crown. Open on both ends. 1-inch open conduit also at this location. Pipe was field discovered. FS Date: 12/22/2016

WS view: steel pipe and electric conduit on levee shoulder.

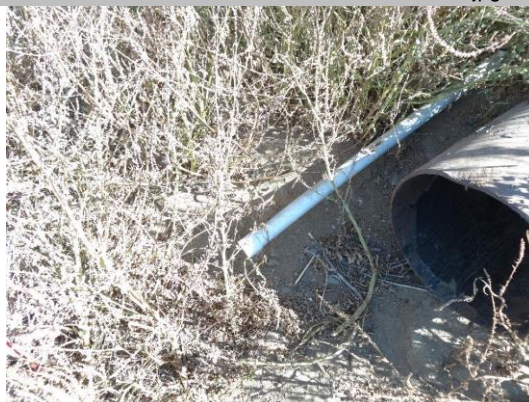
Photo 2 of 3 : UCIP_SP_2017_51380_42976.jpg

LS view: steel pipe and electric conduit on levee shoulder.

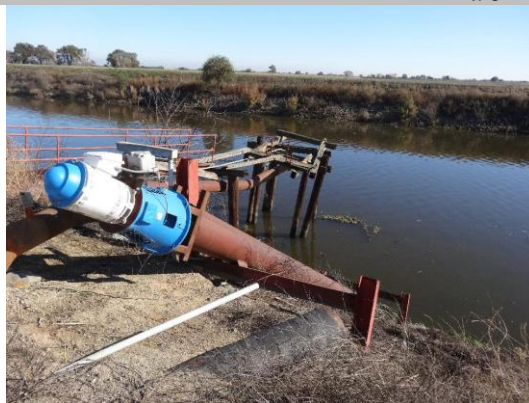
Photo 3 of 3 : UCIP_SP_2017_51380_76632.jpg

LM Start	2.61	Rating **	U	Issue No.	87 (cont)
LM End	2.61	Issue Type +	En	Location *	WS
Category	Supplemental			GPS Latitude/Longitude	
				Start	End
Item	DWR UCIP Field Study			37.818860 °	37.818860 °
				-121.350428 °	-121.350428 °
DWR ID					
Comment Code					
Inspector Comment					
FS_ID:51380 DS_ID:24718 EP_NO: N/A Repair Type: Urgent Crossing Status: Found UCIP Comments: 12/22/2016: Pipe is open on both ends and requires either proper abandonment or flap gate and closure device. Crossing has been upgraded from Non-Urgent to Urgent. (K. Fazel - UCIP)10/31/2013:- needs proper abandonment or closer of pipe end. (P. Amatya - DWR) FIELD_STRUCT_DESC: 14-inch steel pipe through levee, 2 feet below the crown. Open on both ends. 1-inch open conduit also at this location. Pipe was field discovered. FS Date: 12/22/2016

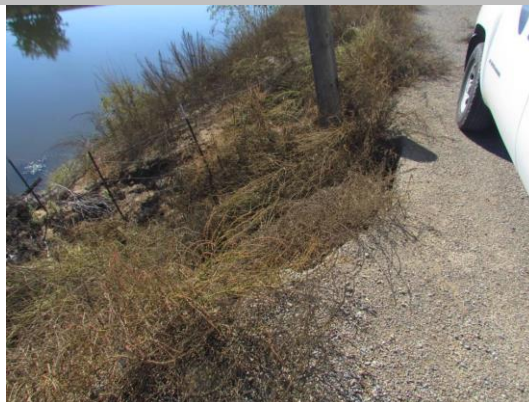
Photo 1 of 3 : SP_2017_RD0544_109_69_20170316_00055.jpg

LM Start	2.61	Rating **	U	Issue No.	69
LM End	2.61	Issue Type +	Ma	Location *	WS
Category	Earthen Levee			GPS Latitude/Longitude	
				Start	End
Item	Erosion / Bank Caving			37.818806 °	37.818806 °
				-121.350437 °	-121.350437 °
DWR ID	DWR_RD0544_02_f_2016_69				
Comment Code					
E2 : Schedule repair of erosion site prior to the next inspection.					
Inspector Comment					
Erosion greater than 1' deep and greater than 3' wide.

Looking south at erosion on waterward shoulder and slope.

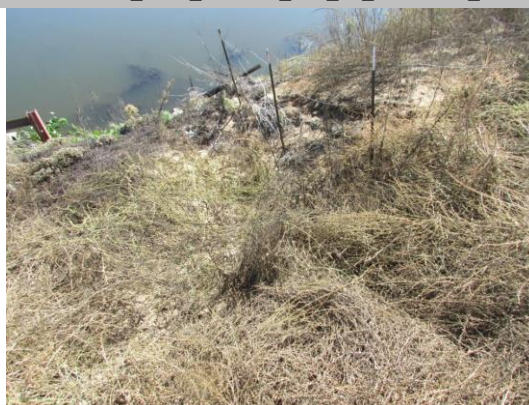
Photo 3 of 3 : SP_2017_RD0544_109_69_20170316_00057.jpg

Looking south at waterward erosion.

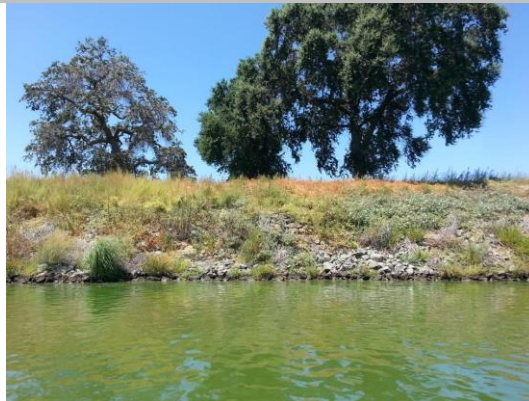
Photo 1 of 2 : SP_2017_RD0544_109_7_20170316_00005.jpg

LM Start	2.68	Rating **	M	Issue No.	7
LM End	2.70	Issue Type +	Ma	Location *	WS
Category	Supplemental			GPS Latitude/Longitude	
				Start	End
Item	DWR Erosion Survey			37.817905 °	37.817905 °
				-121.351102 °	-121.351102 °
DWR ID	DWR_RD0544_02_s_2017_7				
Comment Code					
Inspector Comment					
07/25/2016: No significant change observed.					
06/25/2015: No significant change observed.					
07/02/2014: No significant change observed.					
10/11/2013: No significant change observed.					
08/07/2012: Series of pocket erosion were discovered at the levee toe during the boat survey. The area is covered with vegetation and riprap, but the rip rap has been washed away. [2016 Site ID:RD0544U02RM32.91]

Front view of the pocket erosion. Note the vegetation and riprap at the site.

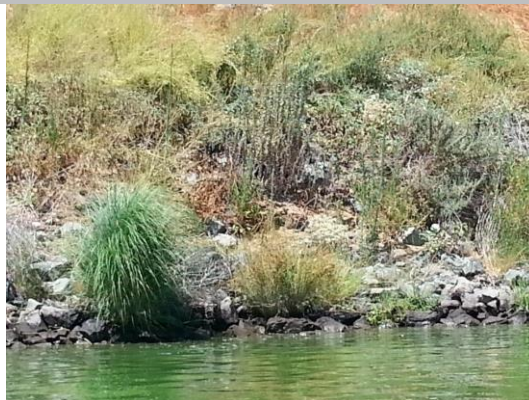
Photo 2 of 2 : SP_2017_RD0544_109_7_20170316_00006.jpg

Close view of the erosion.

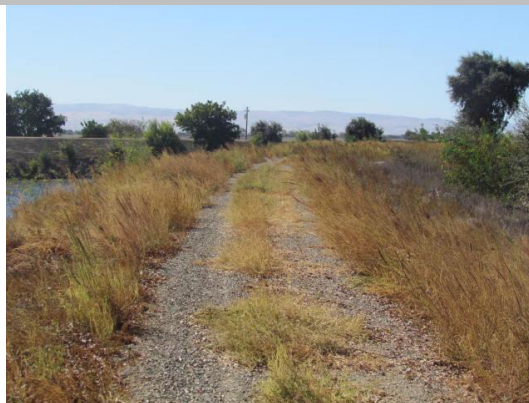
Photo 1 of 1 : SP_2017_RD0544_109_52_20170316_00042.jpg

LM Start	2.69	Rating **	M	Issue No.	52
LM End	3.20	Issue Type +	Ma	Location *	CR
Category	Earthen Levee			GPS Latitude/Longitude	
				Start	End
Item	Vegetation			37.817928 °	37.818824 °
				-121.351355 °	-121.359523 °
DWR ID	DWR_RD0544_02_f_2014_52				
Comment Code					
V2 : Remove the wild growth other than native grasses from the levee slopes.					
Inspector Comment					
LMA placed new gravel on crown. Some minor areas of vegetation still exist on crown.

Looking south at vegetation on levee crown.

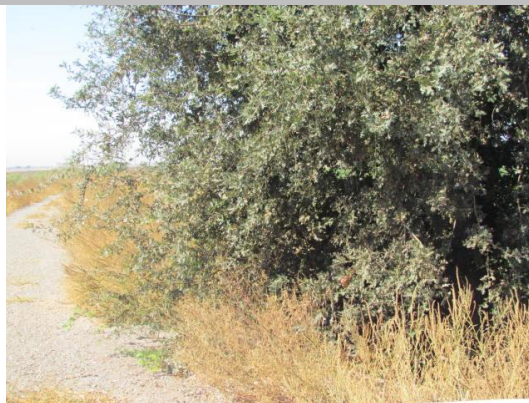
Photo 1 of 1 : SP_2017_RD0544_109_53_20170316_00043.jpg

LM Start	2.80	Rating **	U	Issue No.	53
LM End	2.80	Issue Type +	Ma	Location *	LS
Category	Earthen Levee			GPS Latitude/Longitude	
				Start	End
Item	Trim / Thin Trees			37.817187 °	37.817187 °
				-121.352964 °	-121.352964 °
DWR ID	DWR_RD0544_02_f_2014_53				
Comment Code					
T2 : Thin trees to allow visibility of the ground and room to flood fight.					
Inspector Comment

Looking southwest at untrimmed tree on landward slope fall 2015.

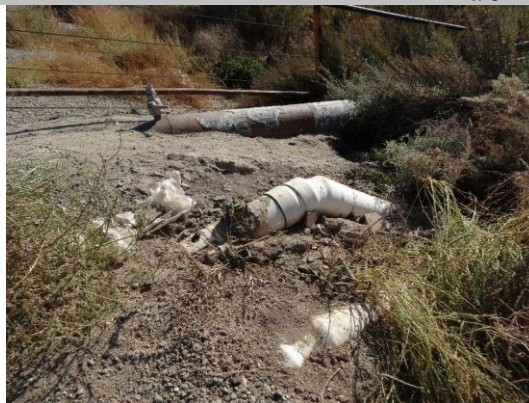
Photo 1 of 3 : UCIP_SP_2017_24908_44898.jpg

LM Start	3.20	Rating **	M	Issue No.	88
LM End	3.20	Issue Type +	En	Location *	WS
Category	Supplemental			GPS Latitude/Longitude	
				Start	End
Item	DWR UCIP Field Study			37.818824 °	37.818824 °
				-121.359526 °	-121.359526 °
DWR ID					
Comment Code					
Inspector Comment					
FS_ID:24908					
DS_ID:22679					
EP_NO: 16972					
Repair Type: Non-Urgent					
Crossing Status: Found					
UCIP Comments: Pump not found on the waterward side.Damaged pipe-plug on waterside. Pipe exposed on both sides of the levee.					
FIELD_STRUCT_DESC: 1 of 2: Two 8-inch pvc pipes (replaced two 8-inch steel pipes) through the levee, 2.0 feet below the crown. Siphon breaker on waterside. Pump on steel platform in drainage ditch. (App. No. 16972 - Joseph & Gayle Muller)					
FS Date: 10/31/2013

WS view: 12" steel pipe (top), two 8" white pvc pipes (bottom) on levee shoulder.
